# **INDOOR AIR QUALITY ASSESSMENT**

**Hopedale Town Hall  
Main Street  
Hopedale, Massachusetts**

Prepared by:  
Massachusetts Department of Public Health  
Bureau of Environmental Health Assessment  
June, 2000

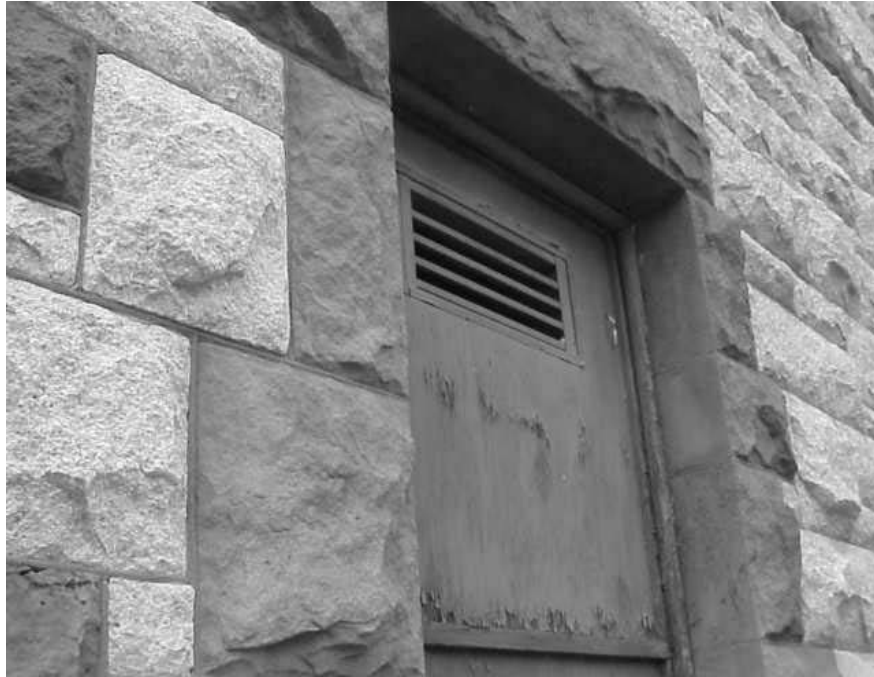
**Picture 1**

**Fresh Air Intake Vent**

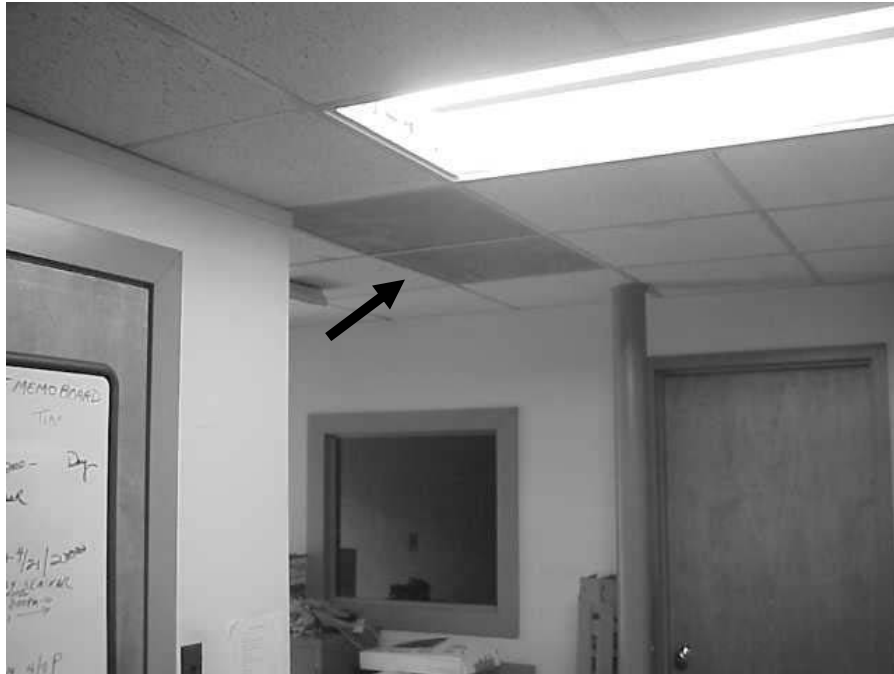
**Picture 2**

**Plastic Grates that Serve as the Return Air Vent**

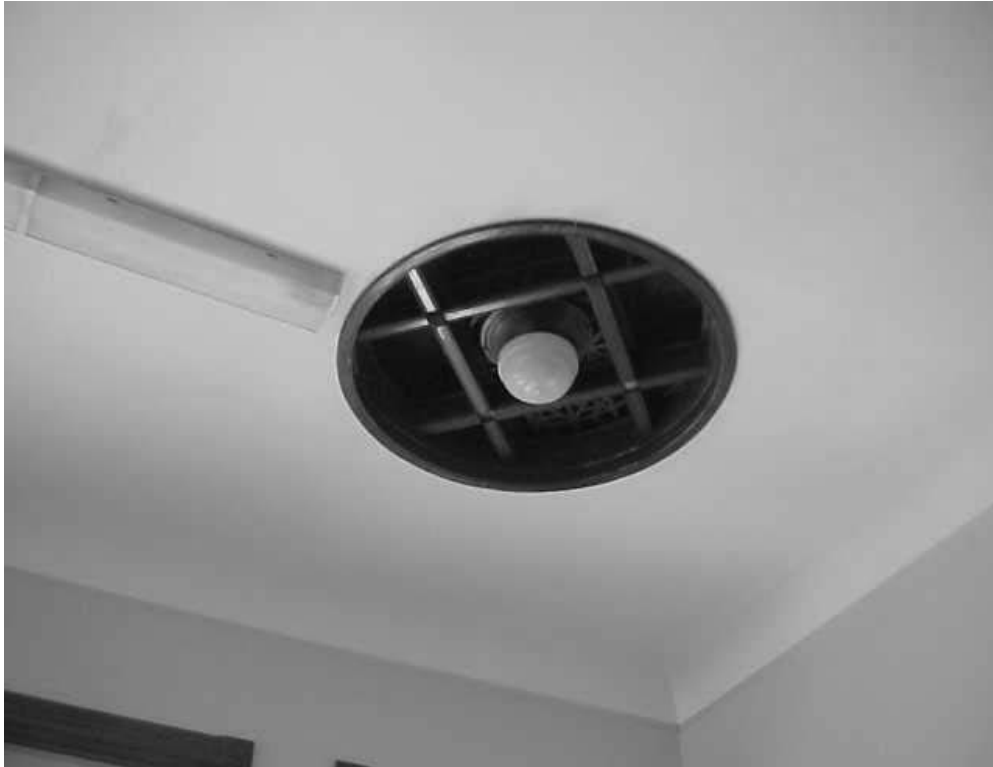
**Picture 3**

The auditorium does not have a mechanical fresh air supply. Several passive vents around light fixtures are located in the ceiling (see Pictures 3 and 4). Several trap doors exist in the floor of the attic. When these trap doors are opened, the passive vents

**Passive Vent in Auditorium**

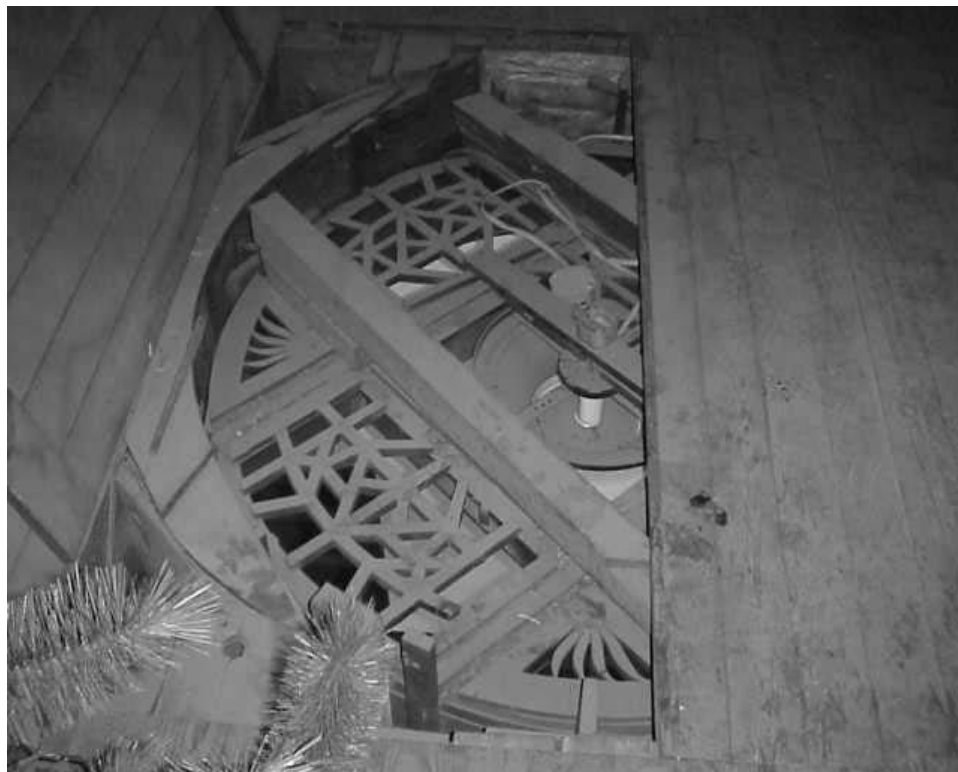
**Picture 4**

**Trapdoors for Passive Auditorium Vents in Attic**

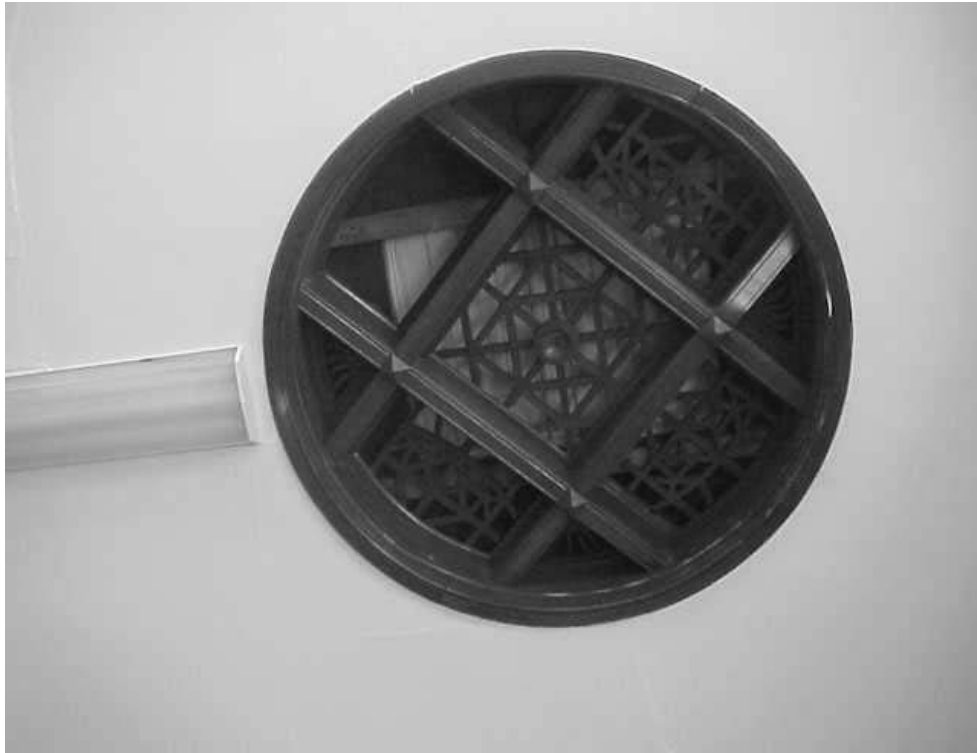
**Picture 5**

are opened. A mechanical exhaust vent appears to be retrofitted over one of the light fixture vents (see Pictures 5 and 6). This mechanical exhaust vent could not be activated during the assessment.

**Passive Vent Retrofitted With Fan, Note Missing Light Fixture In Center Of Vent**

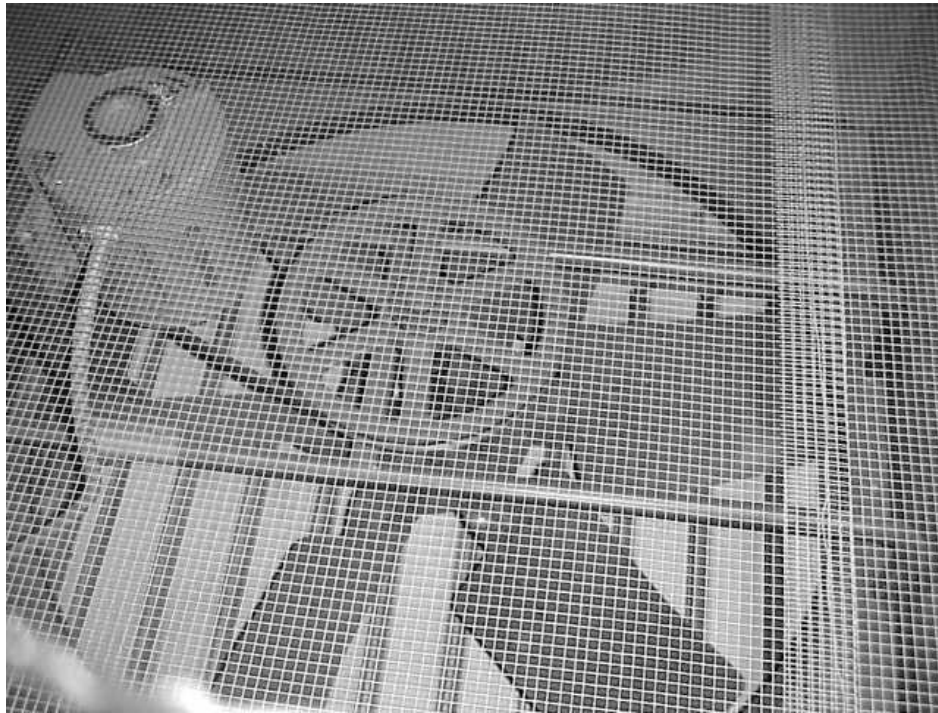
**Picture 6**

**Auditorium Exhaust Fan in Attic**

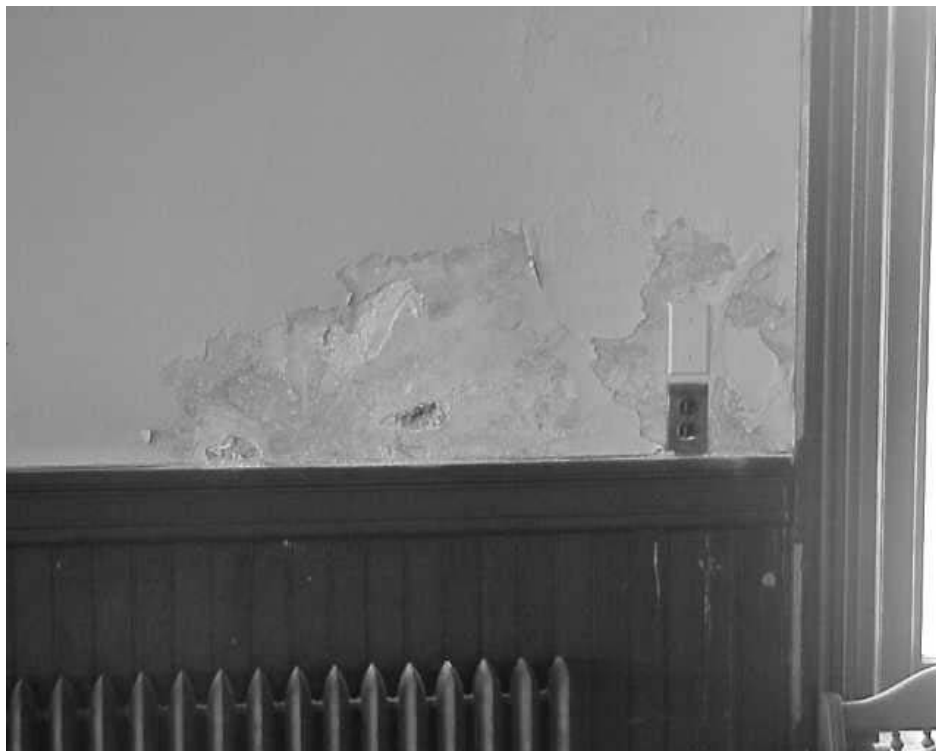
**Picture 7**

A number of interior areas in the building have signs of water damaged wall plaster (see Picture 7). The source of water damaged plaster appears to be water penetration through either wooden window frames (see Picture 8), or seams of exterior wall brick (see Picture 9). Water damaged wall plaster can serve as a mold growth medium, especially if wetted repeatedly.

**Water Damaged Plaster in Auditorium**

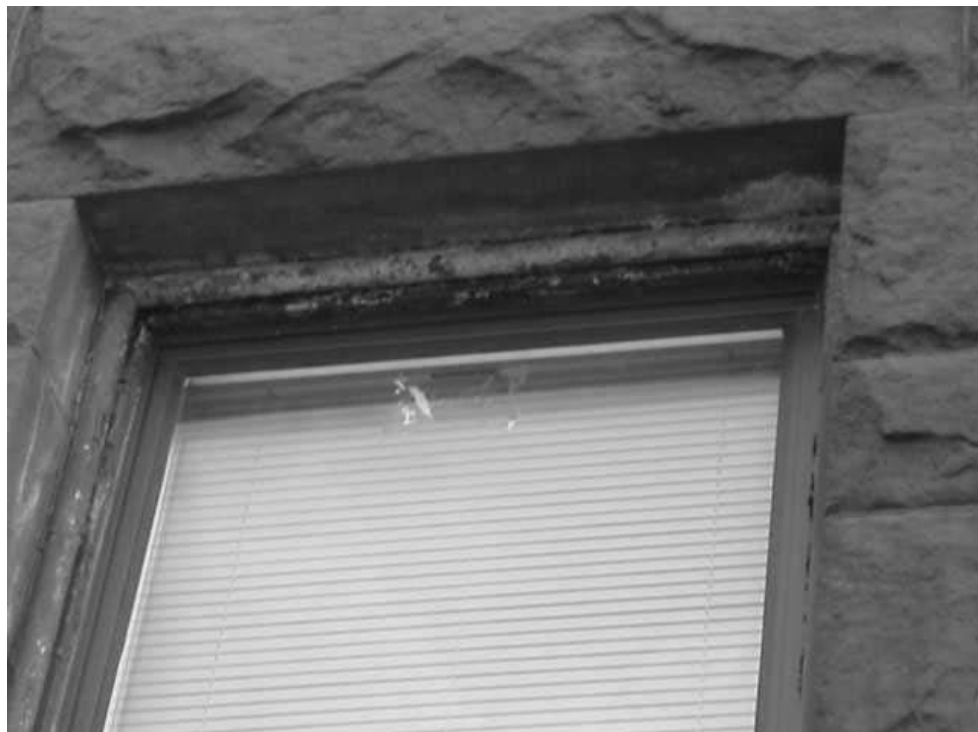
**Picture 8**

**Water Damaged Wood of Window Frame**

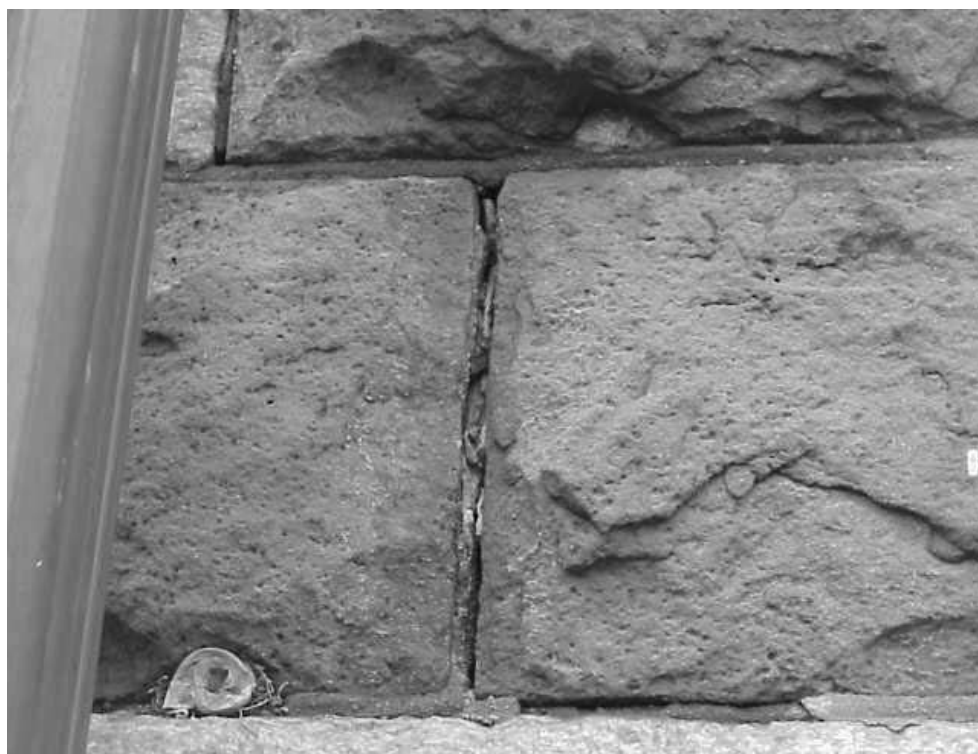
**Picture 9**

**Damaged Brick Mortar in the South Exterior Wall**

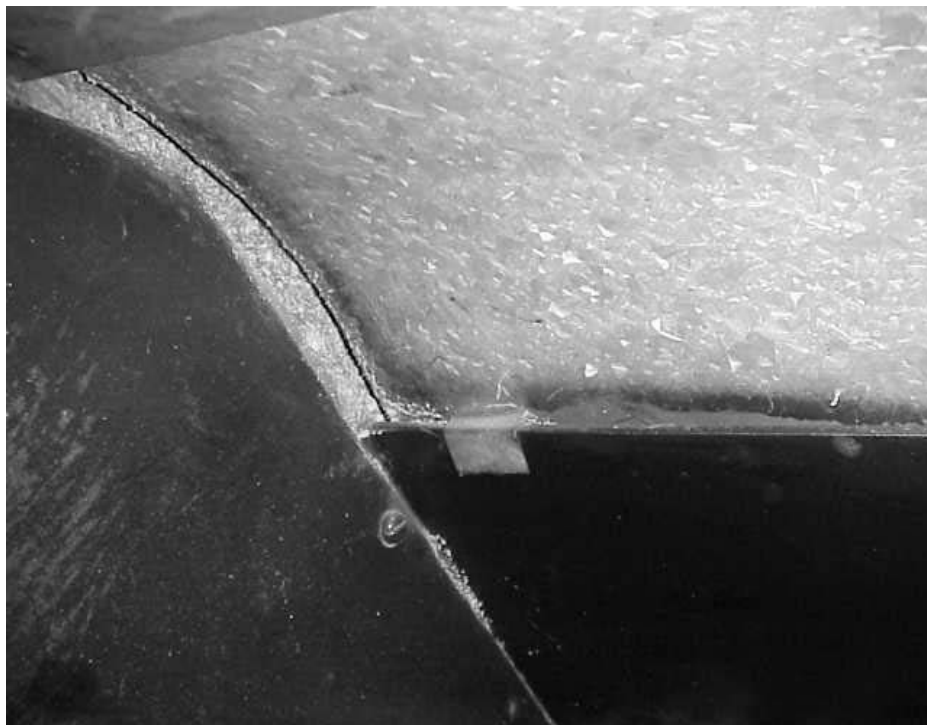
**Picture 10**

The Board of Selectmen's office contains a fireplace that is sealed (see Picture 10). The face of the ironwork within the fireplace is coated with a dried powdery material (see Picture 11). The attic floor at the base of the chimney above this fireplace is coated with powdered brick and mortar (see Picture 12). The white material coating the fireplace ironwork and chimney brick is efflorescence. Efflorescence is a characteristic sign of water intrusion. As penetrating moisture works its way through mortar around brick, it leaves behind characteristic mineral deposits. The most likely source of moisture is rainwater penetrating into the chimney. Chimneys lack caps to prevent water penetration. Over the course of the building's existence, it appears that rainwater has

**Material Used to Seal Chimney in Selectmen's Office**

Drinking water during the day can help ease some symptoms associated with a dry environment (throat and sinus irritations). Consideration should be given to obtaining a vacuum cleaner equipped with a high efficiency arrestance (HEPA) filter to reduce the aerosolization of respirable particulates in the building.
7. Identify if the rainwater downspout system is draining properly to prevent further water damage in the basement.
8. Consider pointing exterior brick.
9. Repair water damaged wood window frames and interior plaster.
10. Seal unused chimneys on the roof to eliminate water penetration. For chimneys still in use, consider installing a chimney cap to prevent rainwater penetration.
11. Remove seal on second floor fireplace and remove accumulated debris.

Reseal fireplace.
12. Replace water damaged flooring near the basement closet in the west side of the basement.

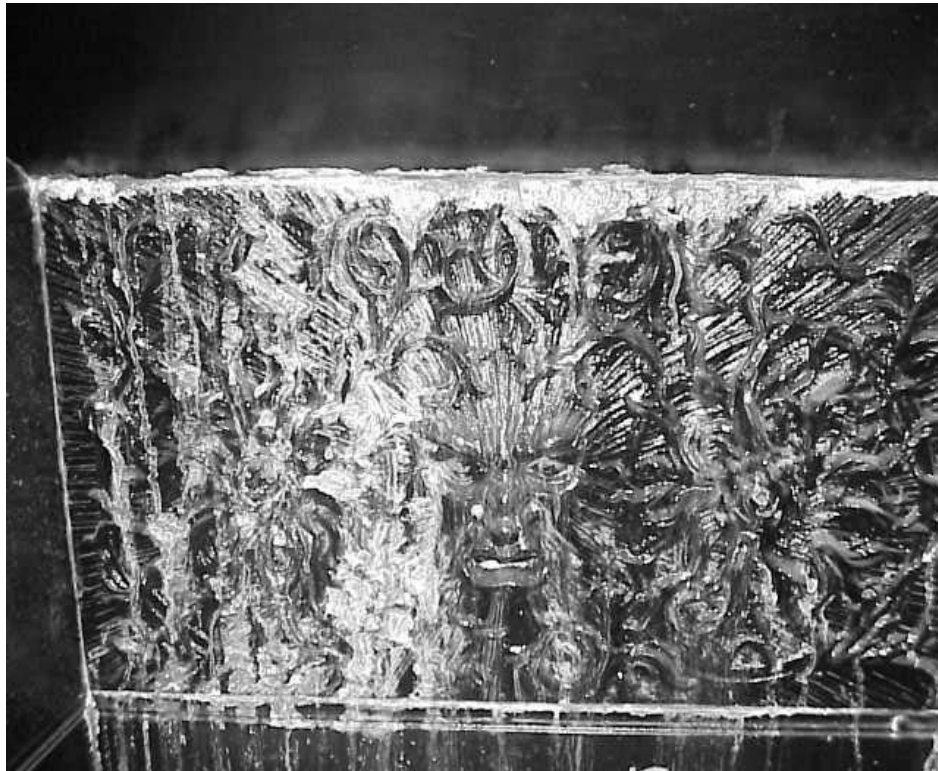
**Picture 11**

**Back Wall of Fireplace in Selectmen's Office, Note White Coating**

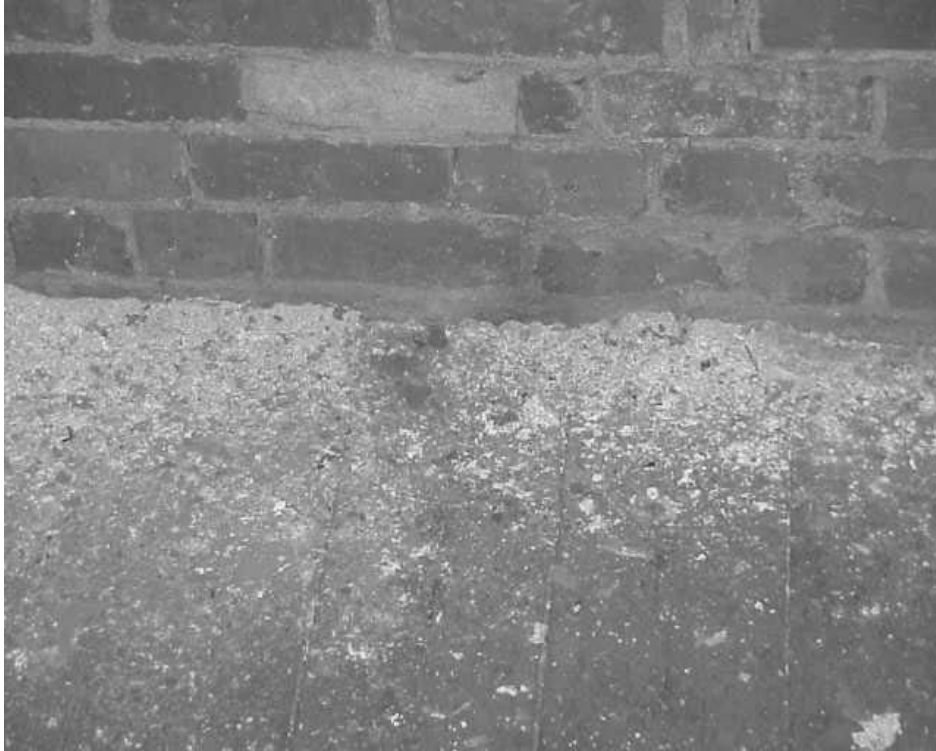
**Picture 12**

penetrated into the chimneys and over time, resulted in water damage. Paper and boxes around the chimney and accumulated materials above the fireplace plug can become wet during rainstorms. These materials can absorb moisture and can serve as media for mold growth. Mold grows in cycles, which creates spores, mold fragments and other related problems. These particles can become aerosolized with increased airflow over contaminated materials.

**Powdered Brick and Mortar of Chimney on Attic Floor**

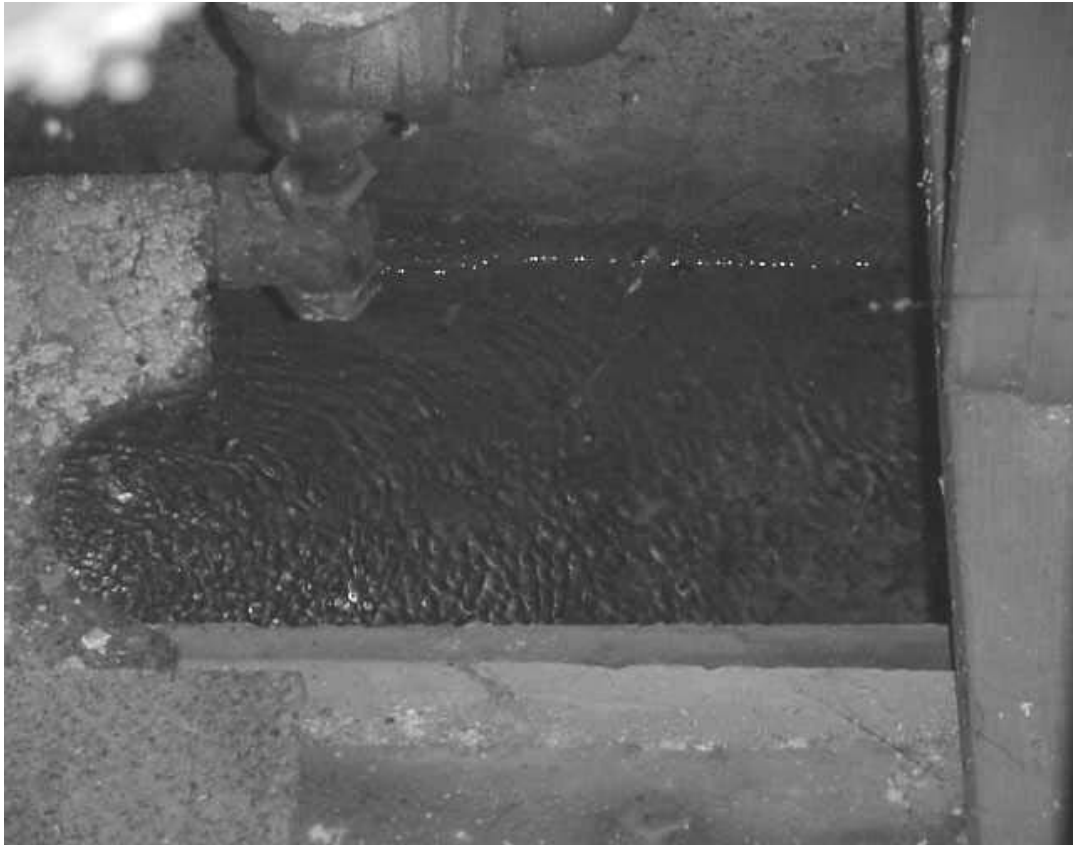
**Picture 13**

The basement of the town hall has two drainage troughs that run from the front of the building towards the rear along the floor. One floor trough runs into the length of the water department area floor. The second trough's course could not be determined because it is covered by a raised false floor of basement offices that houses the board of health, building department, hallway, restrooms and elder affairs office. While the trough in the water department area was dry, running water was found beneath the false floor of the basement town offices (see Picture 13). The integrity of part of the floor in a closet near the restrooms appeared to be compromised, which may be an indication of water damage in the flooring wood. If the drain to this trough becomes clogged without stopping the source of running water, flooding can result in the basement.

**Running Water in Floor Trough beneath the Board of Health Office**

1. Maximize the amount of fresh air drawn through the fresh air vents. Once the fresh air supply and exhaust systems are functioning, have the system balanced by a ventilation engineer.
2. Consideration should be given to provide higher efficiency air filters for the heat pump in order to reduce dusts.
3. Repair the exhaust vent motor in the attic.
4. Determine the source of running water below the floor of the basement offices and repair.

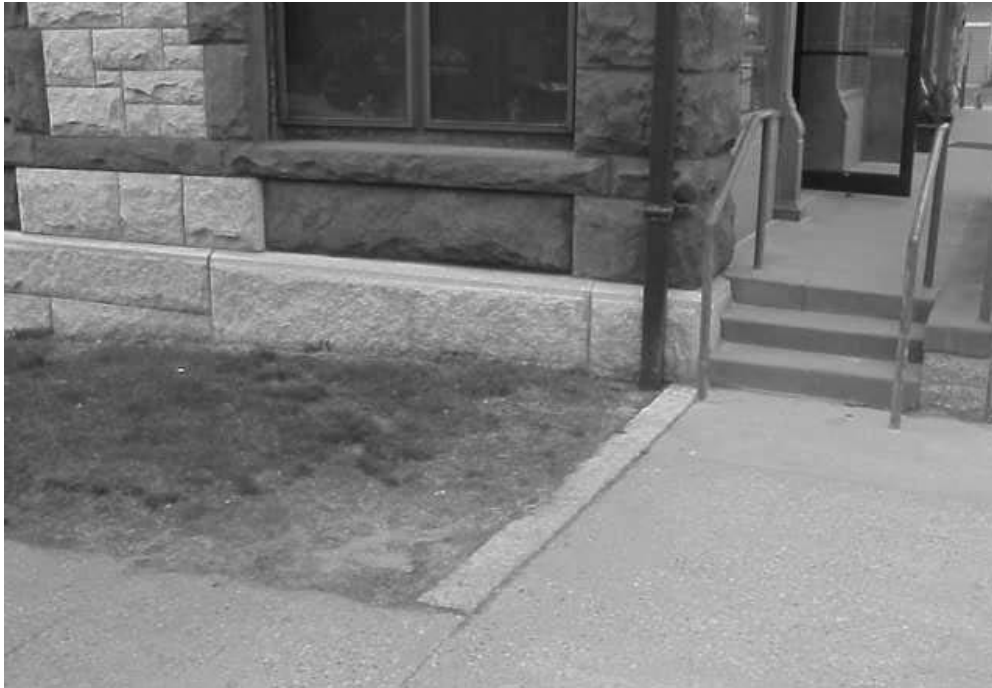
**Picture 14**

The northeast corner of the basement was reported to have experienced a termite infestation. Beams in this area show signs of holing and wood degradation, which are usually signs of termite infestation. Steps to rid the building of termites were taken. Termite infestation usually begins in moistened wood. Around the corners of the building are rainwater gutters and downspouts. Downspouts are buried (see Picture 14) and reportedly drain through a system in the rear parking lot. It is possible that this

drainage system is leaking, resulting in water penetrating into the basement and wetting the beams.

**Underground Downspout at the Northeast Corner of Building**

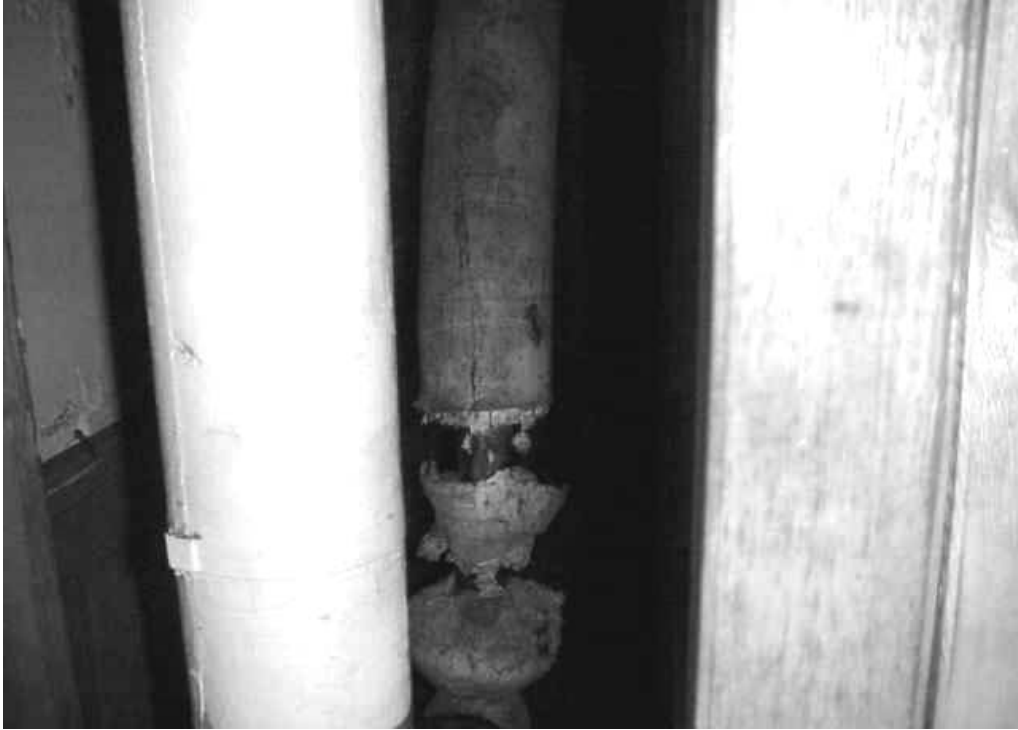
**Picture 15**

The heating system in the basement has insulated pipes. In the board of health storage closet (see Picture 15) and the water department (see Picture 16), the ends of this insulation are not encapsulated and appear to consist of white, chalky material. The material may contain asbestos and should be remediated in conformance with all applicable Massachusetts asbestos abatement and hazardous materials disposal laws. The restrooms in the basement have no mechanical ventilation. Restrooms are primary sources of moisture and standing water.

**Pipe Insulation in Board of Health Storage Closet**

5. Ascertain whether the pipe wrap in basement contains asbestos and encapsulate or remove in conformance with Massachusetts law.
6. For buildings in New England, periods of low relative humidity during the winter are often unavoidable. Therefore, scrupulous cleaning practices to minimize common indoor air contaminants whose irritant effects can be enhanced when the relative humidity is low should be implemented.

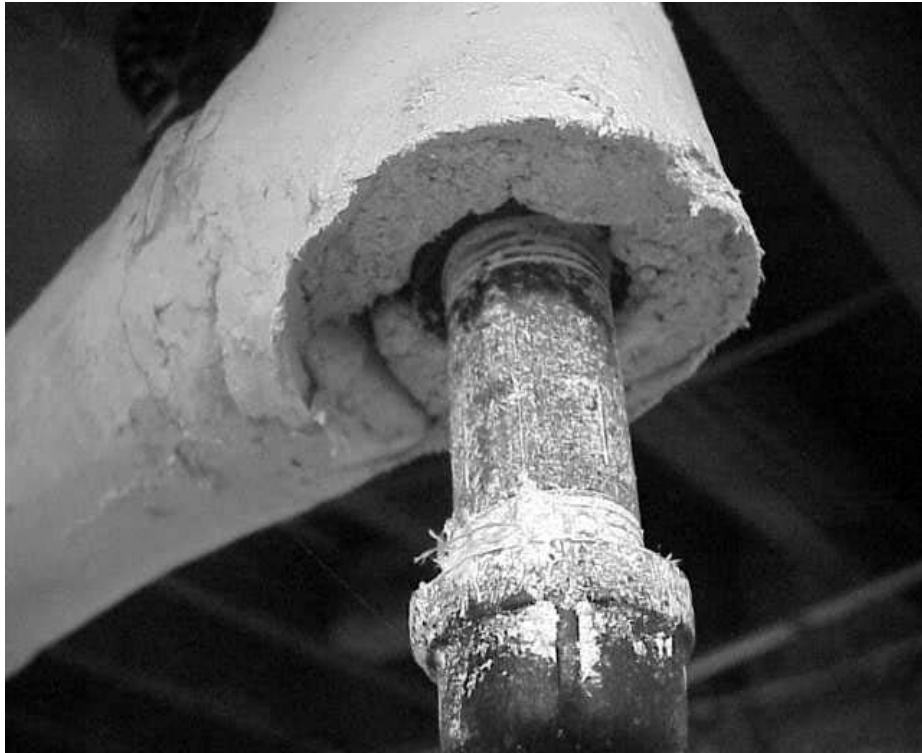
**Picture 16**

**Pipe Insulation Noted in the Water Department  
Basement Work Area**
